**Flood Control Project Maintenance  
Levee Inspections**

**Fall 2011 Levee Maintenance Deficiency Summary Report**

**Reclamation District No. 2096 Wetherbee Lake**

**Levee Inspection Report By Mile - Fall 2011**

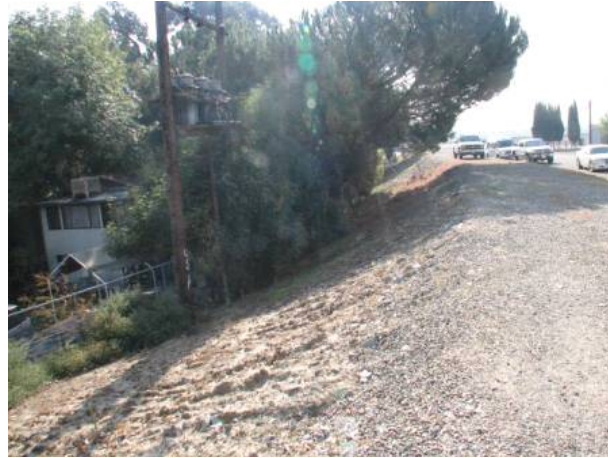
Levee Mile Report Line	1
Start Levee Mile	0.04
End Levee Mile	0.17
Location	Land Side
Category	Earthen Levee
Item	Encroachments
11/09/2011 Fence at toe of levee.	
jeto_f_20111118_593.jpg

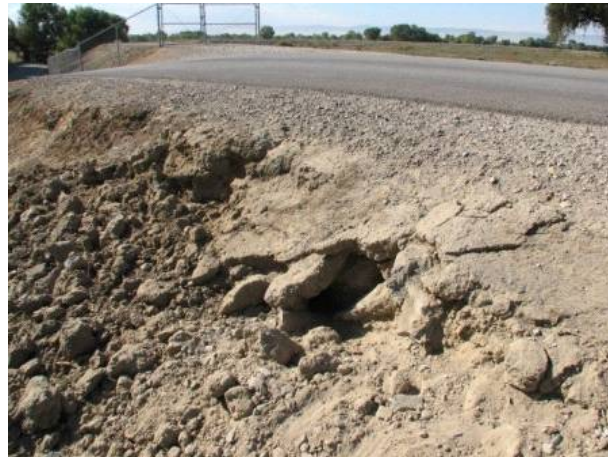
Levee Mile Report Line	2
Start Levee Mile	0.10
End Levee Mile	0.10
Location	Land Side
Category	Earthen Levee
Item	Animal Control
Levee slope was recompacted and rodents have reestablished their den at this location.	
jeto_f_20110923_377.jpg

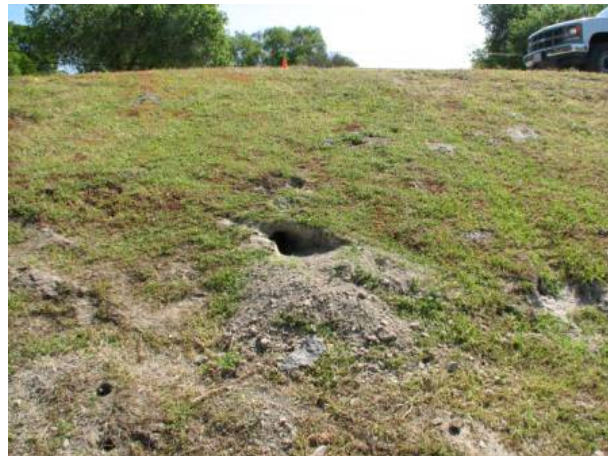
Levee Mile Report Line	2
Start Levee Mile	0.10
End Levee Mile	0.10
Location	Land Side
Category	Earthen Levee
Item	Animal Control
04/12/2011 Photo shows active burrows in levee on water side.	
jeto_f_20110923_378.jpg

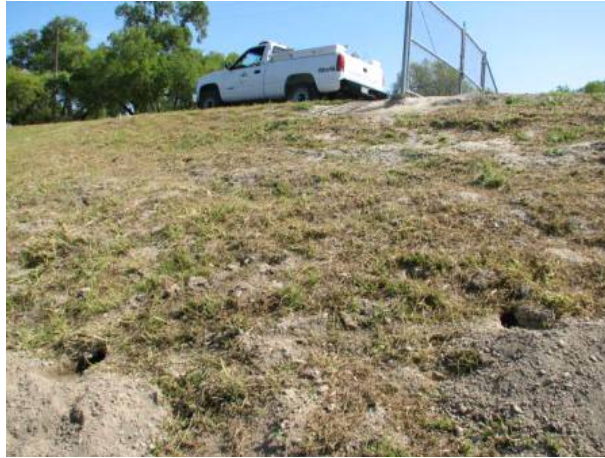
jeto\_f\_20110923\_379.jpg

04/12/2011 Photo shows several burrows in same location, on water side of levee.

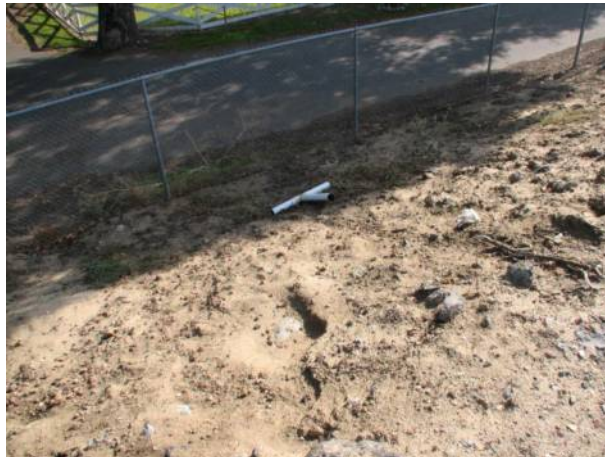
jeto\_f\_20111118\_594.jpg

11/09/2011 Bait station and grouted holes.

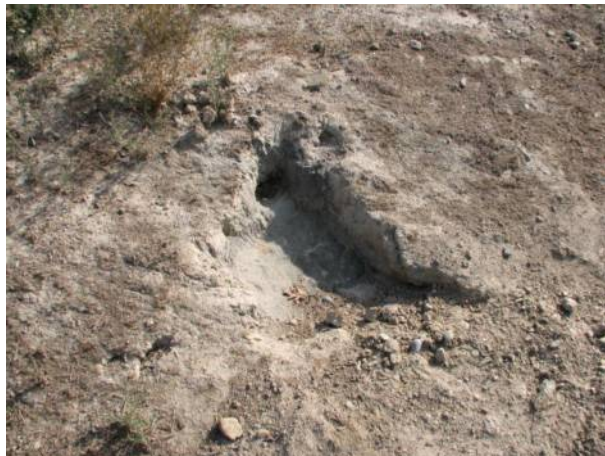
jeto\_f\_20111118\_595.jpg

11/09/2011 Grouted hole, only sign of new burrow activity was at this hole.
